FIELD REPORT

PROJECT: Contact Tank
 Greenburgh, NY

FIELD REPORT NO: 04
ENGINEER'S PROJECT NO: 99010

Work in Progress: Concrete Core Sampling of the Tank Roof Slab

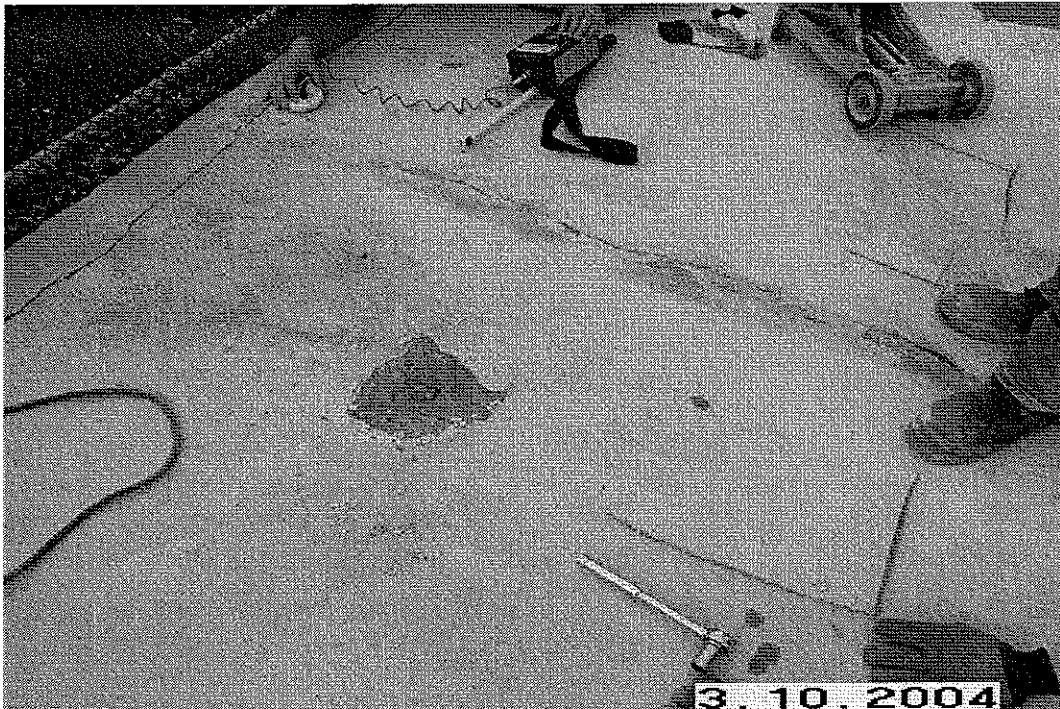
Core samples W1 through W3 were drilled to 8 3/4" and broken off. While setting up for core sample W3, the concrete around the wedge anchor failed while tensioning the wedge anchor bolt. (See photo #1, #7 and #8.) The wedge anchor insert was relocated to the opposite side of the proposed core sample and the core was successfully completed. Cores W1, W2 and W3 will be tested for strength.

Photo No. 1 – Rebar Detection and Spall at West Side

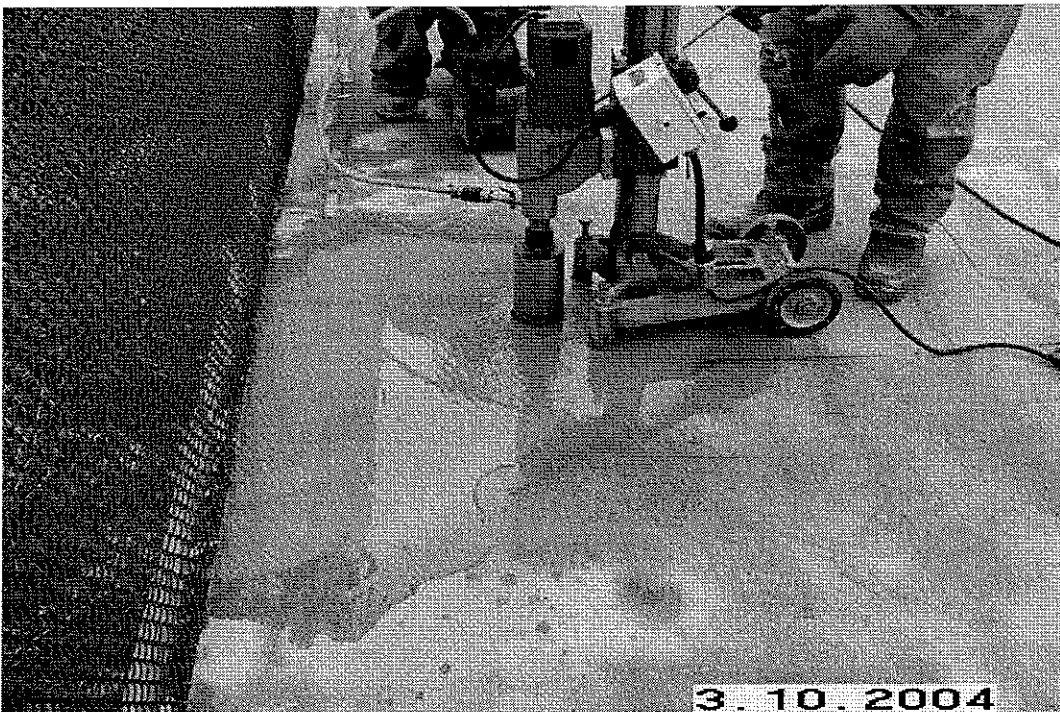
The area from which the core samples were taken was identified by Rick Mahoney of MGM. This location is identified on drawings T1. Greg Discitello used an electronic rebar-location machine to locate cores between the reinforcing bars. Ed Melendez of Fairway Testing set the machine in position and bolted it down at each bore hole. Water was injected into the hollow drill bit to cool the bit during the coring operation. (See photos 1 and 2.)

Photo No. 2 – Core Drilling Machine

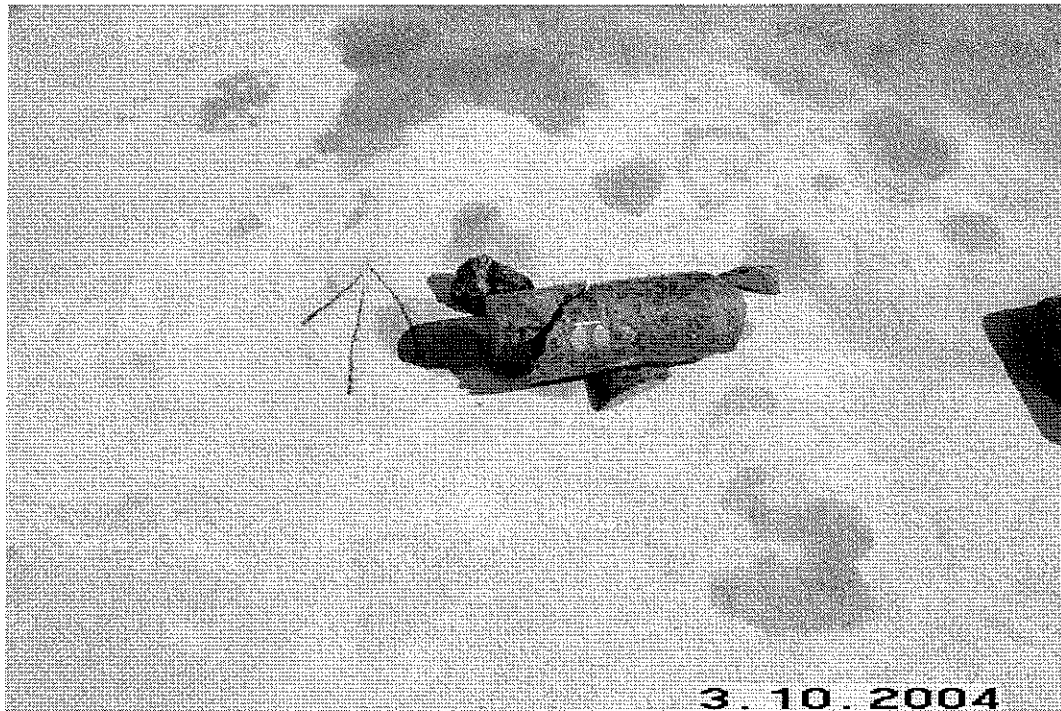
Core Samples E5 and E6 were located on the crack near the edge of the slab. The center of the core samples were located 5 inches from the edge of the slab. The crack at the top of the slab in sample E5 is located at the center of the core. It projects downward approximately 1 3/4" and then goes down towards the east at approximately a 45 degree angle. (See photo #3.) There is a vertically oriented water-stop located at approximately the center of the core. The top of the water-stop is located 11 inches from the top of the slab. The impression of the ribs of the water-stop was visible on the core sample. The crack at the top of the slab in sample E6 is the same size as the crack in sample E5. This crack has formed through the Kim repair material. (See photo #4.) The top of the water-stop in sample E6 leans over at approximately 45 degrees towards the east. The top of the water-stop is 11 1/2" down from the slab surface. The impression of the water-stop ribs is visible on the core sample. (See photo #5 and #6.) There was some difficulty recovering these cores because they were wedged in the hollow drill bit. They were recovered by tapping the outside of the hollow bit releasing the cores. Core samples E5 and E6 will have a petrographic examination according to drawing M.G. McLaren drawing T1 dated December 9, 2004.

Photo No. 3 – Core E5. Top of Core at Left of Slab. Arrow Indicates East.

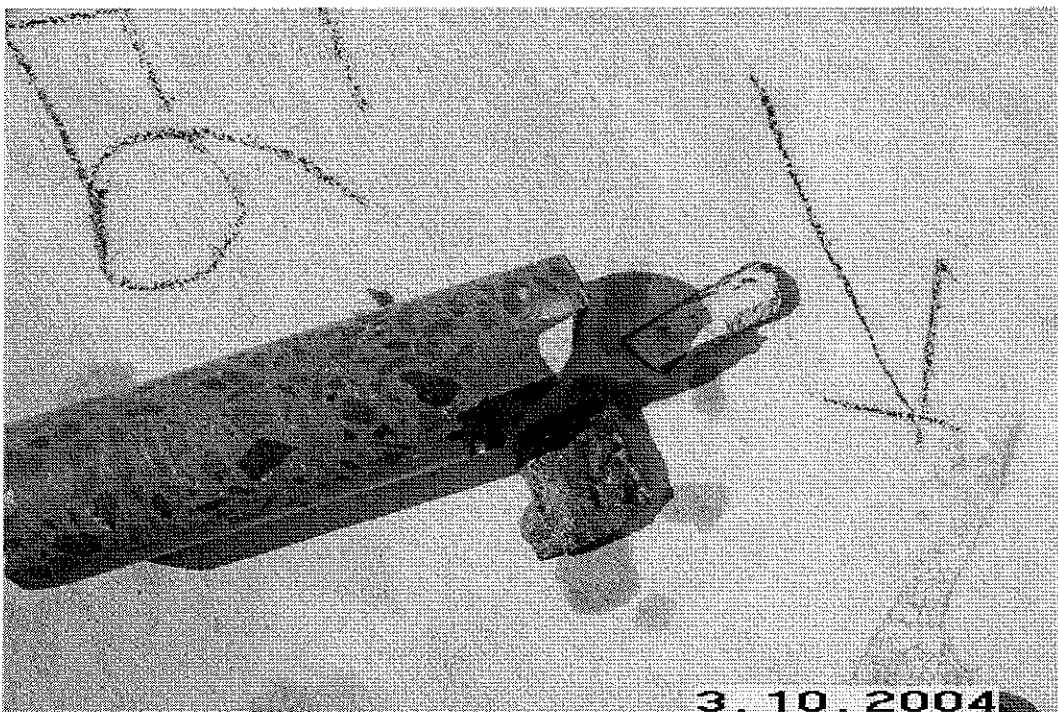
Photo No. 4 – Core E6. Kim Repair Material at Crack at Top of Slab. Arrow indicates East.

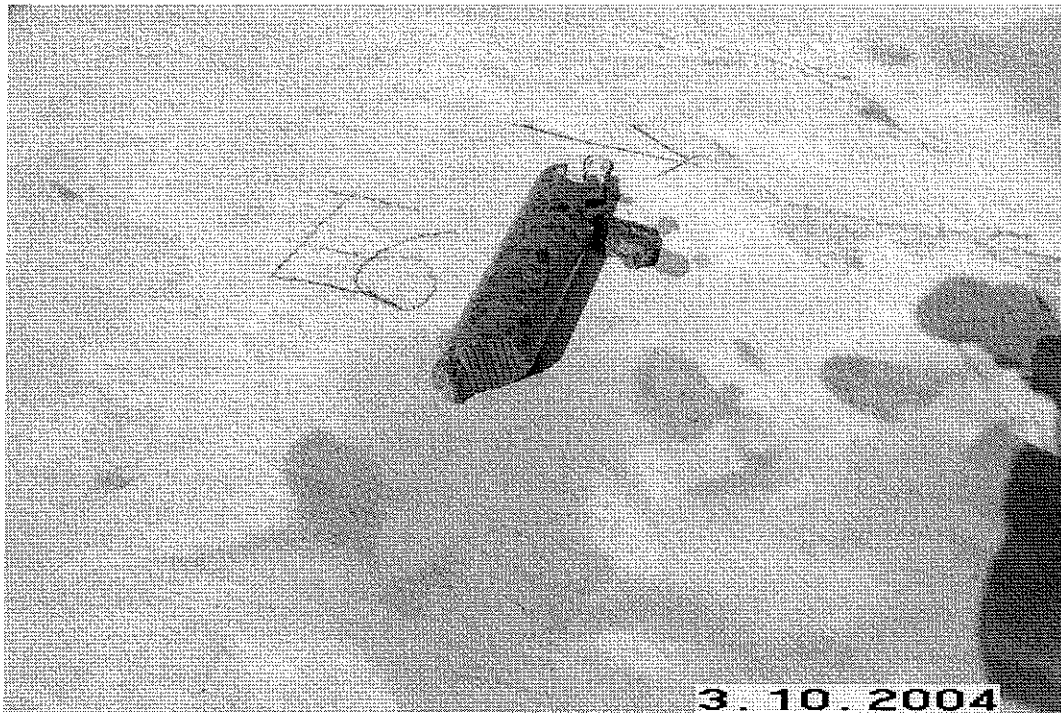
Photo No. 5 – Core E6. Folded over Waterstop Impression at Bottom of Core. Arrow indicates East.

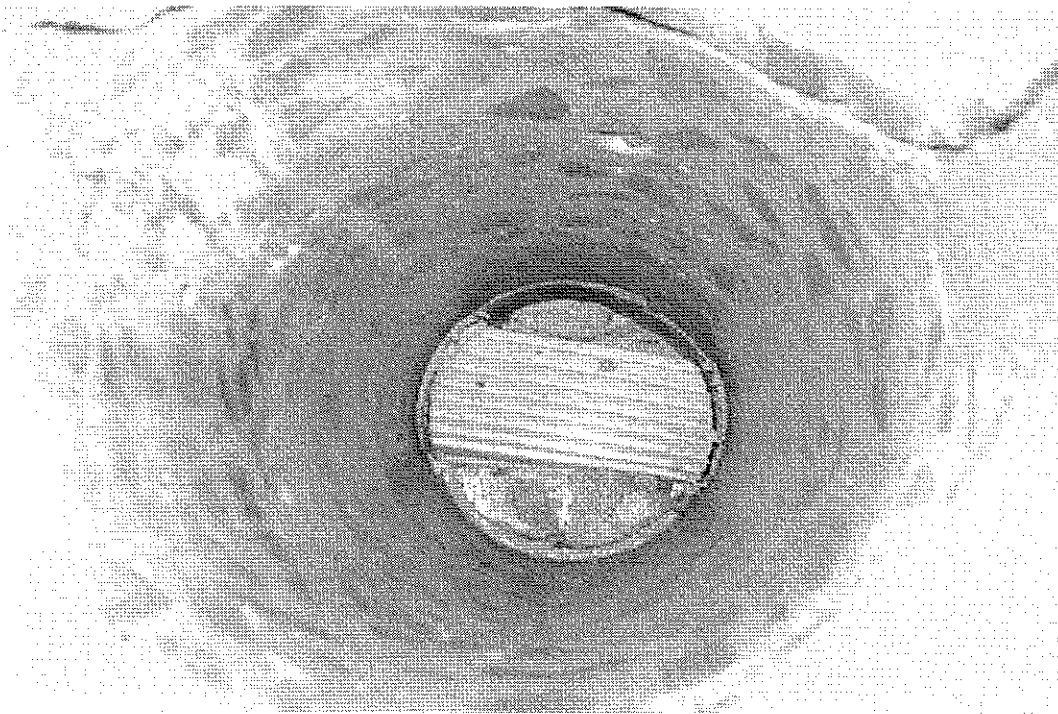
Photo No. 6 – Core E6. Folded Over Waterstop

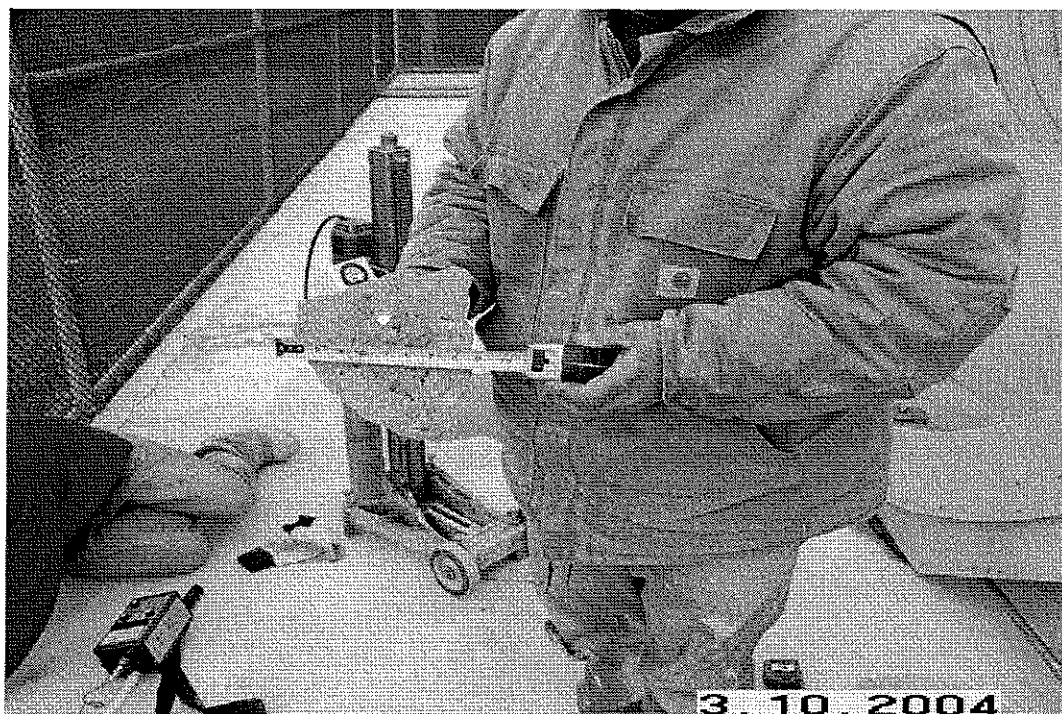
Photo No. 7 – Spall at West Side

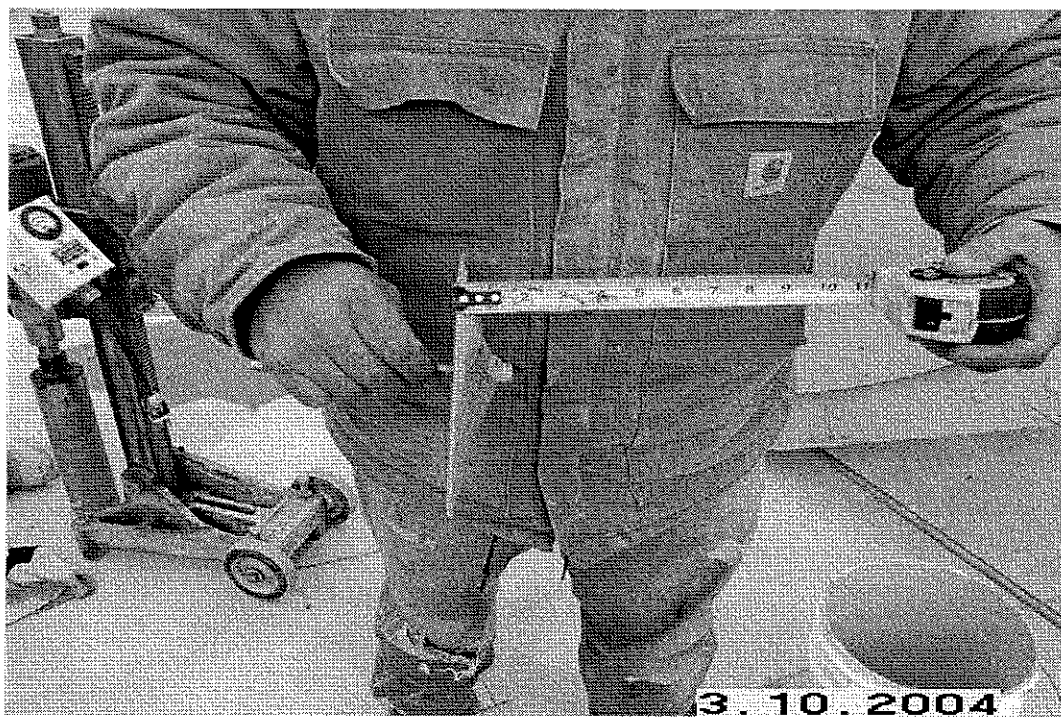
Photo No. 8 – Spall at West Side

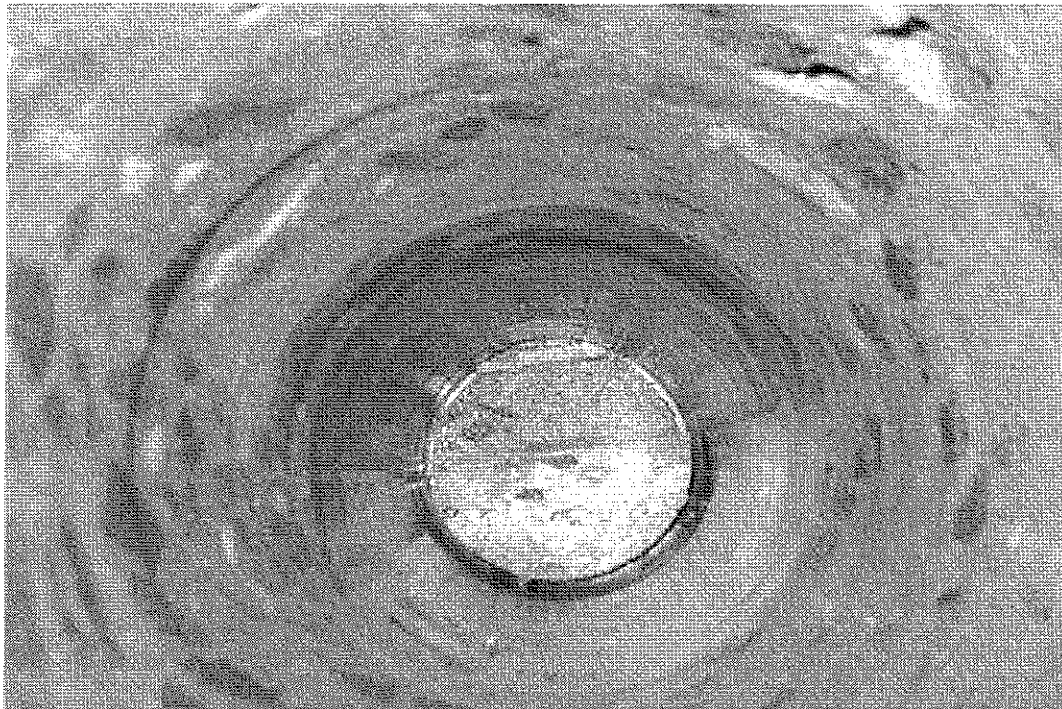
Core sample W5 was 15 inches long. A formed edge was encountered at the bottom center of the core. (See photo #9 and #10.) There was no ribbed impression, such as the ones we had seen from the water-stop in samples E5 and E6.

Photo No. 9 – Core W5
